**INDO AMERICAN JOURNAL OF
PHARMACEUTICAL SCIENCES**

Research Article

EVALUATION OF TWO DIFFERENT TYPES OF ORTHODONTIC MINI-IMPLANTS IMMERSSED IN FLUORIDATED MOUTHWASHES USING SCANNING ELECTRON MICROSCOPY

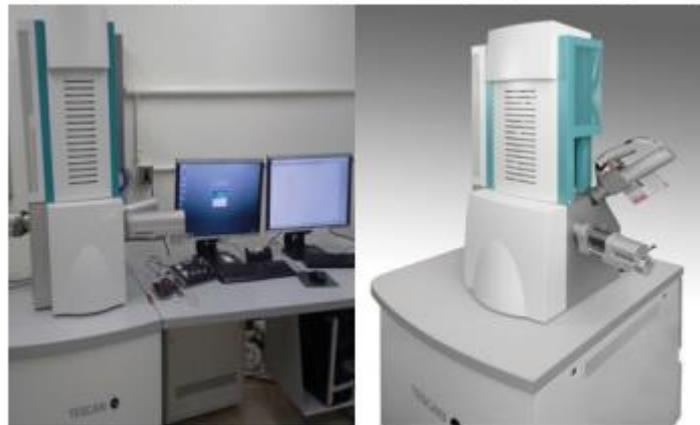
SEM examination was performed to obtain a descriptive analysis of the implant design and qualitative evaluation of MIs surface characteristics as to the presence of any contaminants due to various important factors such as (milling procedure, manufacturing defects, imperfection, and corrosion behavior). The surface microstructure analysis was accompanied using the TESCAN Vega-III high-resolution SEM, equipped with an energy dispersive spectrometer, operated in a high vacuum (HV) mode (Figure 1).

Figure 1 SEM (Model number: TESCAN, Vega III/Czech Republic)

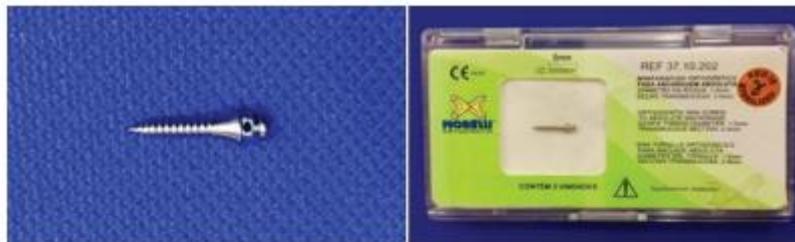
Figure 2 Ti (MI) (Morelli, BRAZIL)

A total of 6 orthodontic MIs: 3 Ti and 3 SS were selected from the examined groups (one from each group) and the surface microstructure analysis was performed twice using SEM. The first time occurred before immersion in the storage medium (artificial saliva, Kin-B5 and Lacalut-white MW), and the second time at the end of the immersion period in which the samples were thoroughly dried and re-sent for SEM analysis (Figures 2, 3).

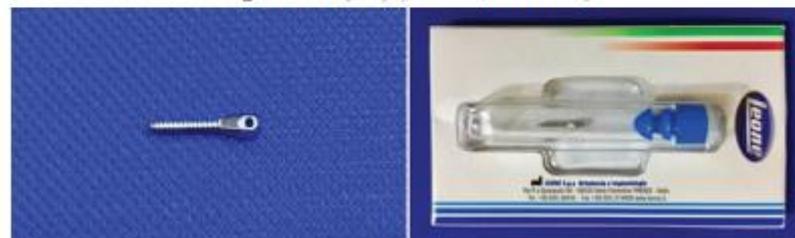
Figure 3 SS (MI) (Leone, Italy)

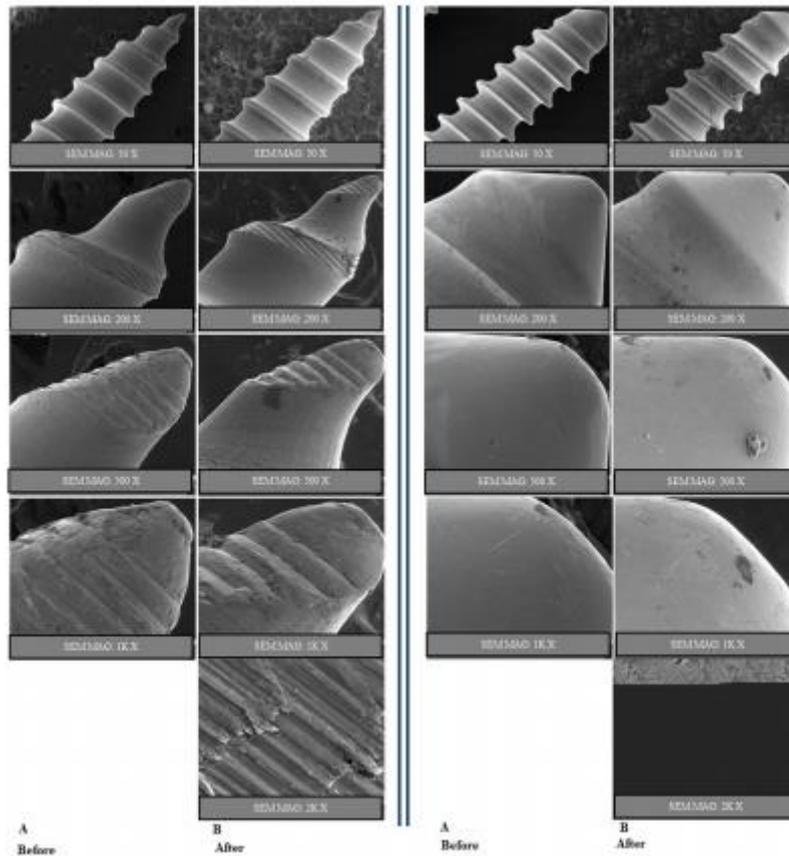
Group 1-A (MI): Soaked in artificial saliva at pH 6.75. Figure 4 showed relatively lower surface roughness and corrosion compared to Kin-B5 and white Lacalut immersed in MW (Group 2 and Group 3) at pH 6.5 and 5.5, respectively. MI teeth showed surface roughness and corrosion of cracks in female body joints, and holes and pits were clearly visible in the pictures at high magnification (Fig. 4).

Group 1-B (MI): immersed in artificial saliva, Fig. 4 showed fewer cracks and pitting on the surface compared to the other two SS groups.

Figure 4 Group 1 (A,B) before and after the immersion in artificial saliva, A) SEM images of Ti (MIs), B) SEM images of SS (MIs)

surface finish, and consequently a matte appearance in all groups studied. The indicated signs of corrosion were mainly in the form of crevices or pits scattered on the MI surface in various places, mainly in threaded areas, thread connections, the apex area and places of machining defects. All groups had coatings identified in Figure 4-6.

MI before immersion showed that the stainless-steel groups had a smoother surface compared to MI groups. In Figure 4-6, SEM images clearly showed the smooth texture of SS groups, especially (200X, 500X and 1000X) at magnification. The most common types of corrosion are pitting corrosion and cracking. While the pits appear as a circular or semi-circular area (individually or in groups), finger-shaped protrusions are sometimes presented in the areas of cracks that form microscopic pits.

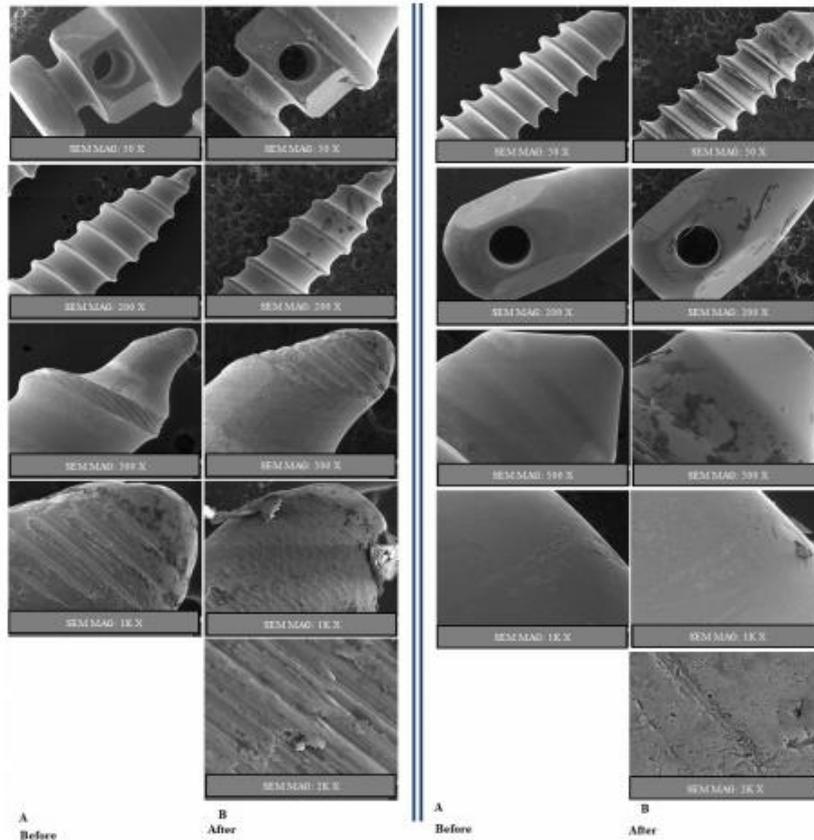
Group 2-A (MI): Kin-B5 immersed in MW pH 6.5. In comparison with (Group 1 and Group 3) it showed greater roughness and pitting corrosion. The head area lost a shiny surface and increased corrosion of cracks and cavities with more pronounced cutouts on the surface (Fig. 5).

Group 2-B (MI): Kin-B5 immersed in MW. Figure 5 shows the largest surface defects and corrosion revealed by SS (MI) after the immersion procedure. Corrosion was represented by pitting on the head, torso and terminal areas of MI, and cracks along the finger joints of women.

Figure 5 Group 2 (A,B) before and after the immersion in (Kin-B5) MW, A) SEM images of Ti (MIs), B) SEM images of SS (MIs)

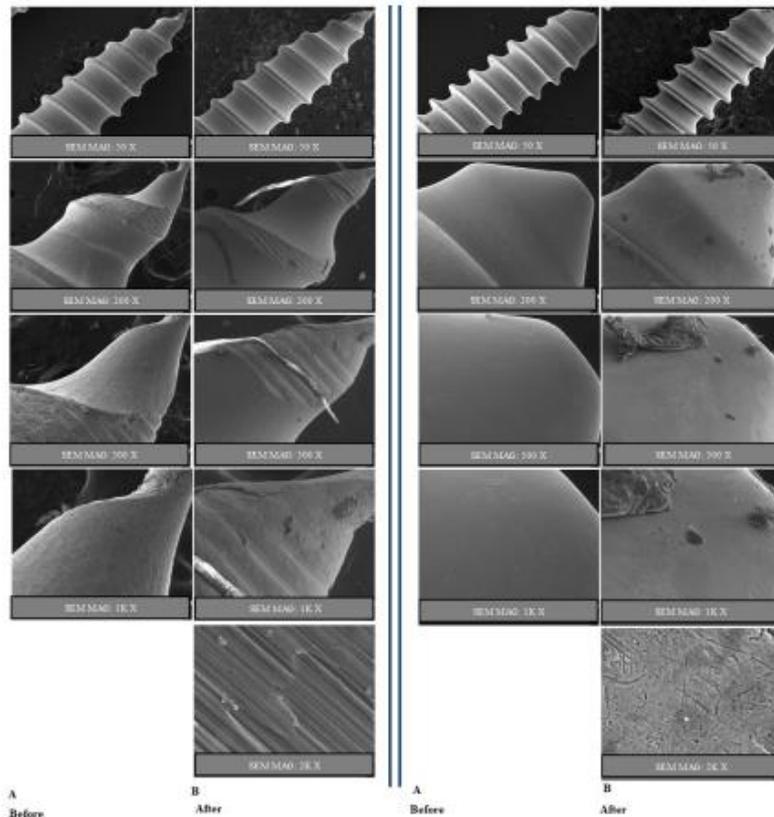
Group 3-A (MI): Lacalut-White MW was submerged at pH 5.5, which showed less pitting and cracking than in the Kin-B5 MW group (Fig. 6).

Group 3-B (MI): Immersed in Lacalut in white MW. Figure 6 similarly appeared with signs of corrosion after immersion. The cavities are less often scattered around the apex area, and less corrosion occurs in cracks containing female joints of the torso and females.

Figure 6 Group 3 (A,B) before and after immersion in (Lactalut-White) MW, A) SEM images of Ti (MIs), B) SEM images of SS (MIs)
